ANALYSIS OF PUMP SHAFT COUPLINGS

IMR Report Number 201000000

SUMMARY

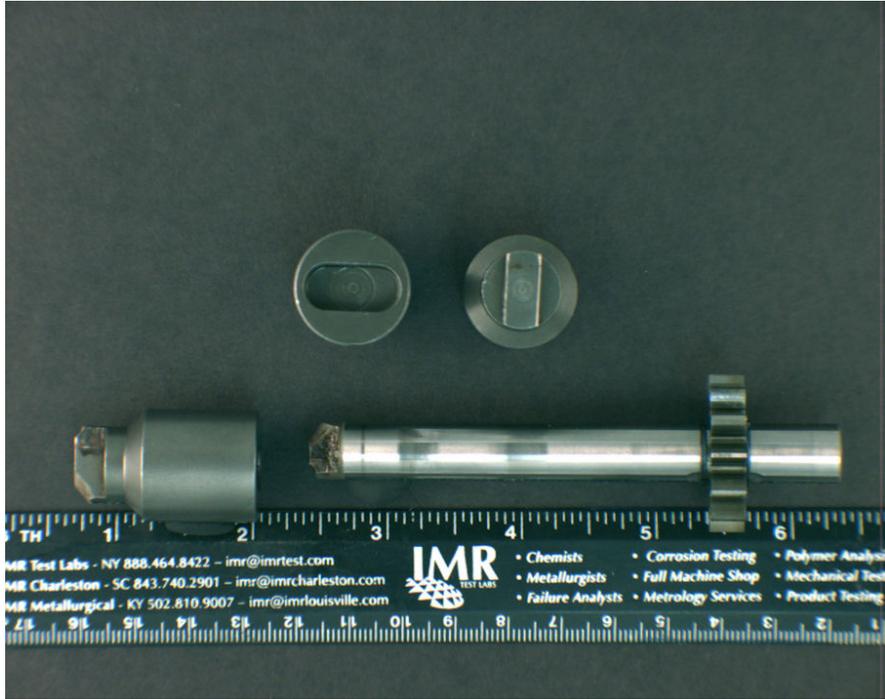
Multiple fractured shaft coupling components (jack shafts), a fractured modular drive shaft, an unbroken pump shaft, and the test stand interface were received. The drive shafts and both couplings had failed at their male tangs during use. Additionally, a jack shaft, which purportedly exhibits greater durability, was received for comparison. Typical components are shown, as received, in Figure 1.

Figure 1: Components, as received.

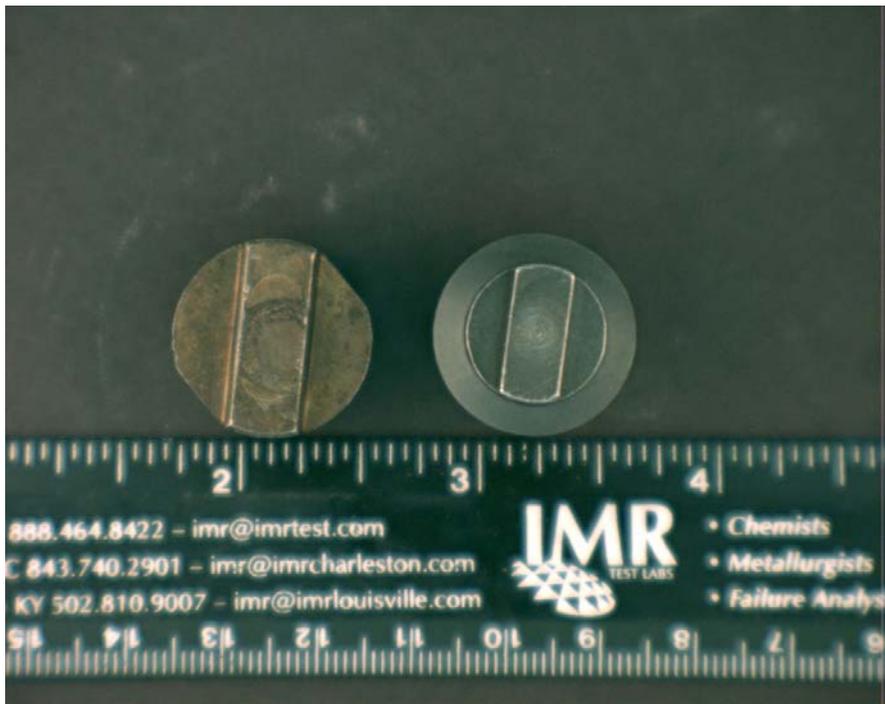
It should be noted significant clearance (<0.02”) is present between mating portions of the components. This would tend to concentrate loads at the ends of the tang, causing higher than expected loading in these regions. It was also noted that the jack shaft provided for comparison has a significantly longer and wider tang, which may help to distribute loads more uniformly (see Figure 2).

Figure 2: Image showing the difference in engagement length between the two jack shafts.

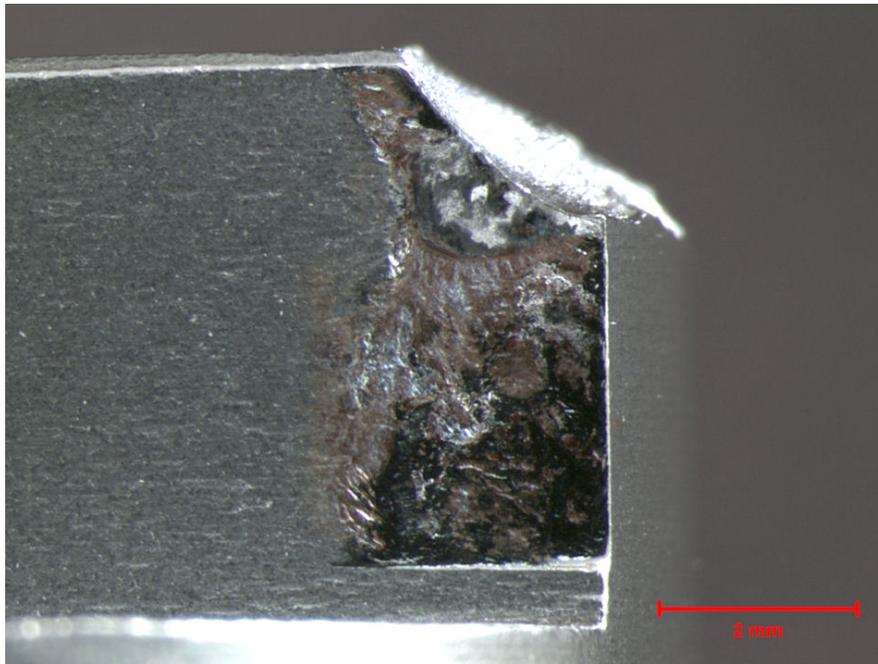
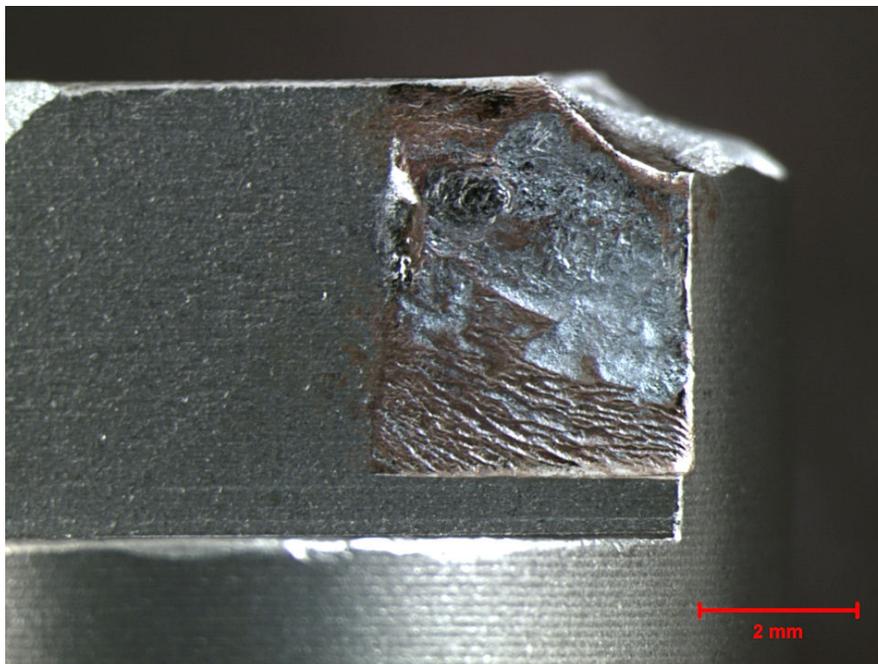
Examination of the fractured components reveals significant wear at the corners of the male tang on both the jack shafts and geared shaft. Red/black discoloration was observed on the worn surfaces. Similar features were noted on the test stand interface; however, the wear and associated discoloration was less pronounced. See Figures 3 – 5. Wear and discoloration of this type are consistent with fretting, which occurs due to oscillation or rubbing between mating surfaces.

Figure 3: Wear pattern and associated reddish-black oxidation products were observed at the engagement points of cracked (top image – crack has been opened in this view) and fractured jack shafts.

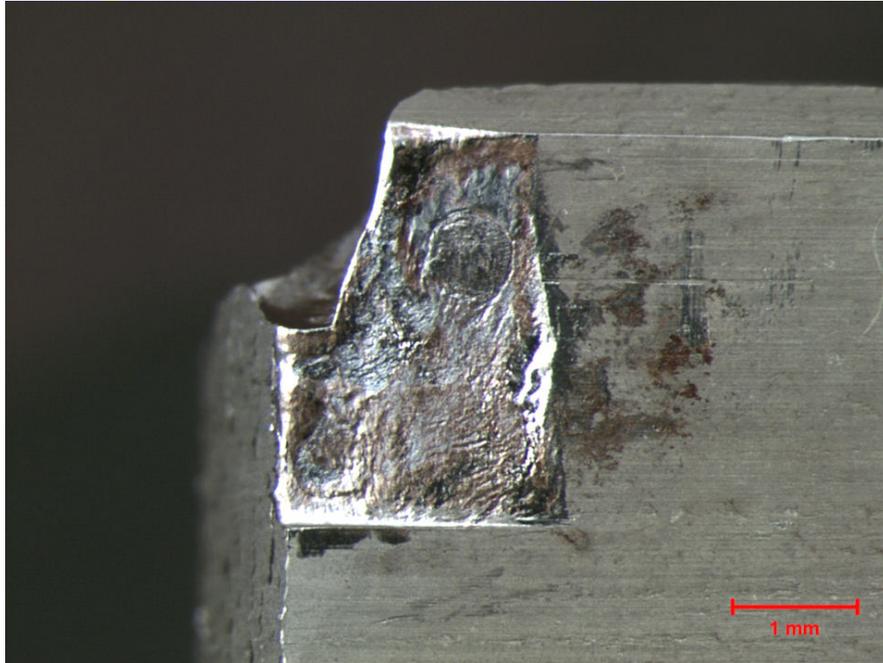
Figure 4: A similar wear pattern was observed at the 98765 shaft engagement points.

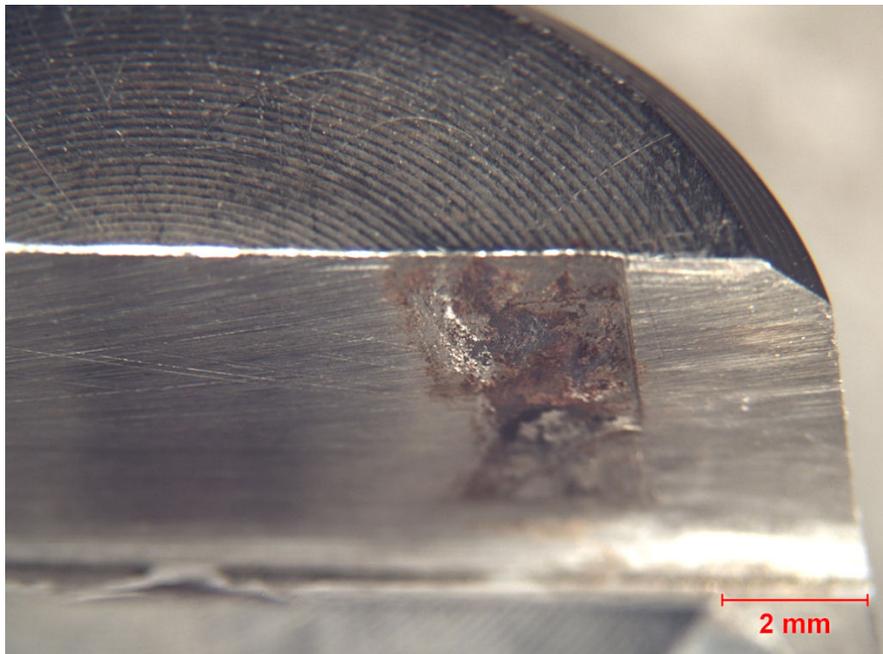
Figure 5: Wear observed on the test-stand fixture was not as extensive as that observed on the couplings.

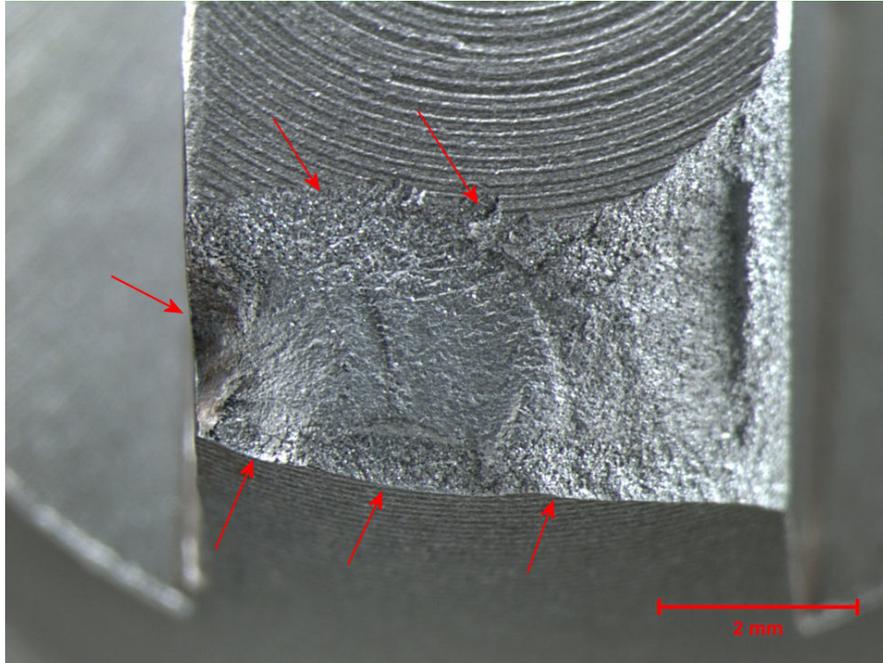
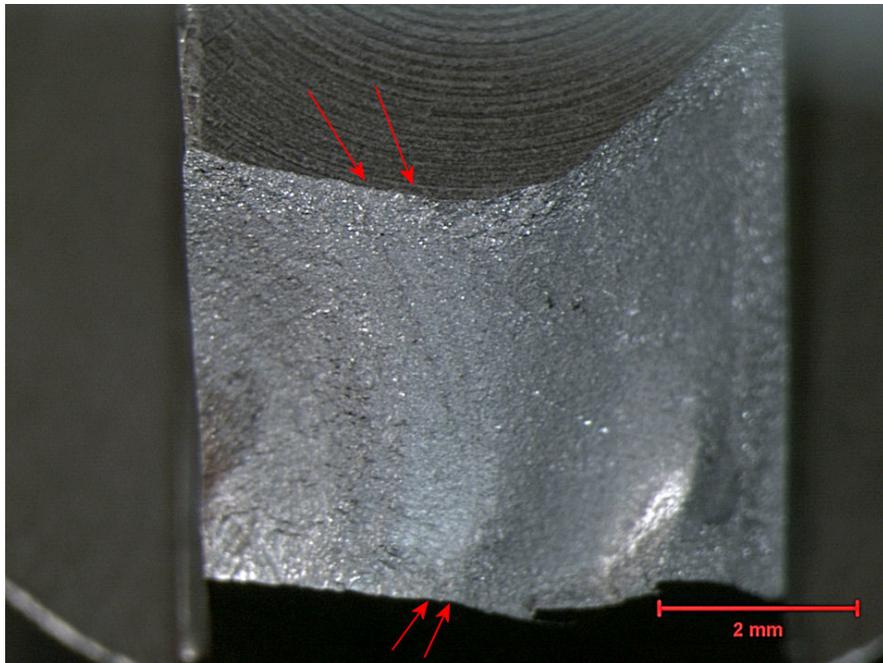
After opening the cracked jack shaft to expose the fracture surface, the samples were cleaned for further evaluation. All three samples showed similar fractographic features: A smooth, reflective region of crack initiation, with beach marks (macroscopic fracture features indicative of fatigue) propagating to the approximate mid-point of the sample, followed by a region of final overload. Initiation was typically between the midpoint and top surface of the worn area in the male tang. See Figures 6 – 8.

Figure 6: The surfaces of both sides of the completely fractured jack shaft showed evidence of beach marks (at arrows).

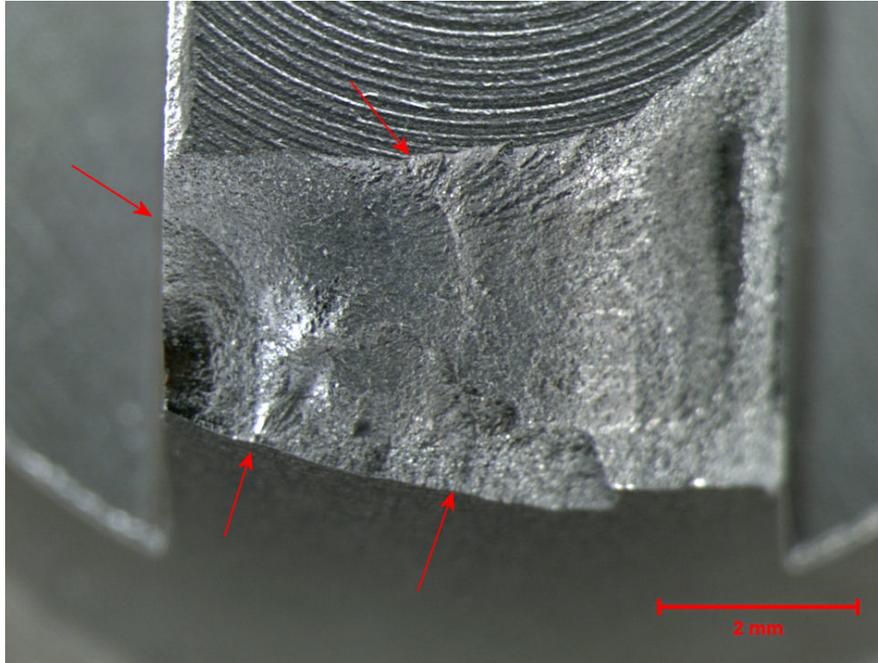
Figure 7: The exposed crack surface of the cracked jack shaft also exhibited beach marks (at arrows).

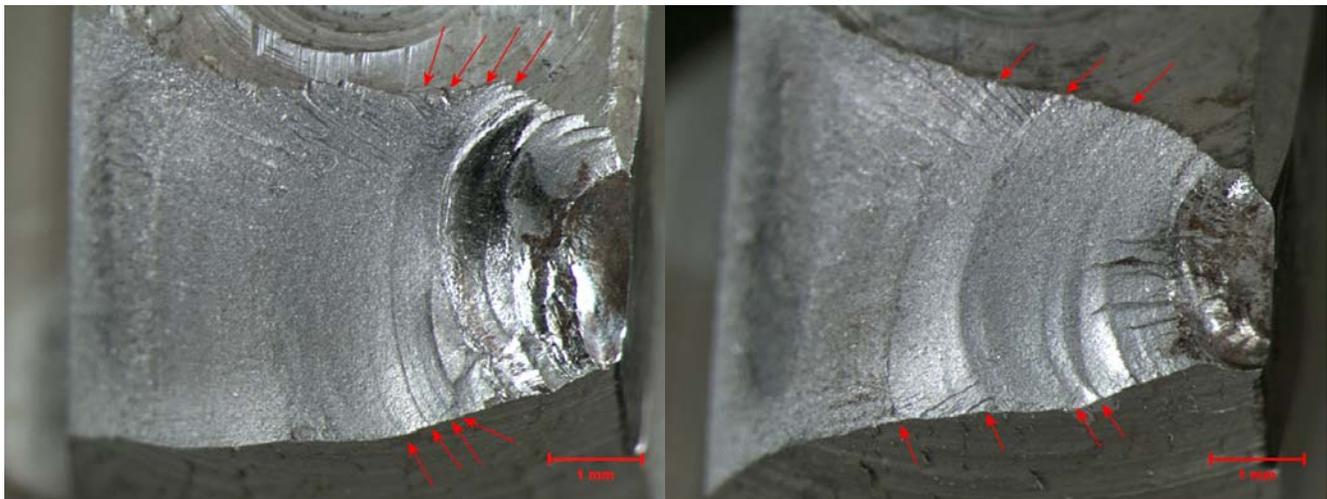
Figure 8: Fractographic features on both fracture surfaces of the 98765 shaft were similar to those observed on the jack shafts.

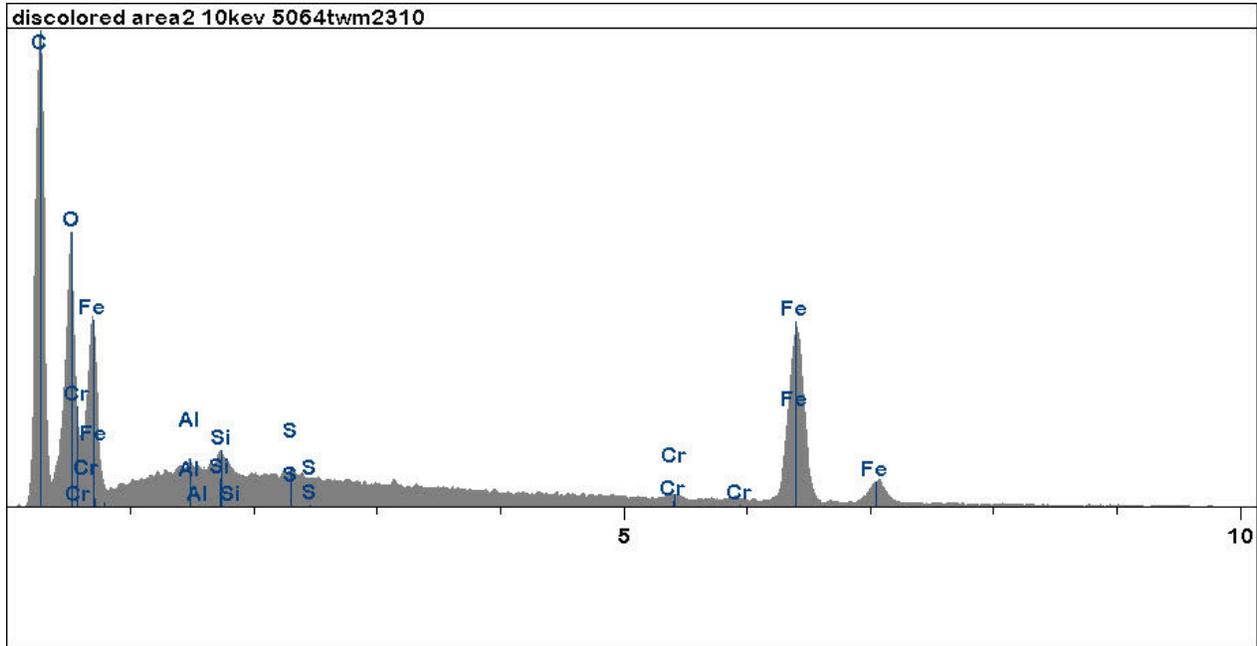
EDS analysis of worn areas reveals the discoloration consists primarily of carbon, oxygen and iron. Silicon, aluminum, sulfur and chromium are present in lesser amounts (Figure 9). The carbon and metallic elements are all present in the substrate material to some extent, with the remaining carbon due to the lubricating grease used on the components. The oxygen is most likely present as an oxide (iron oxide). The presence of significant amounts oxygen in the worn regions supports wear by a fretting mechanism.

Figure 9: EDS chemical analysis of the reddish-black discoloration observed on the samples reveals carbon, oxygen and iron, with silicon, aluminum, chromium and sulfur present in lesser amounts.

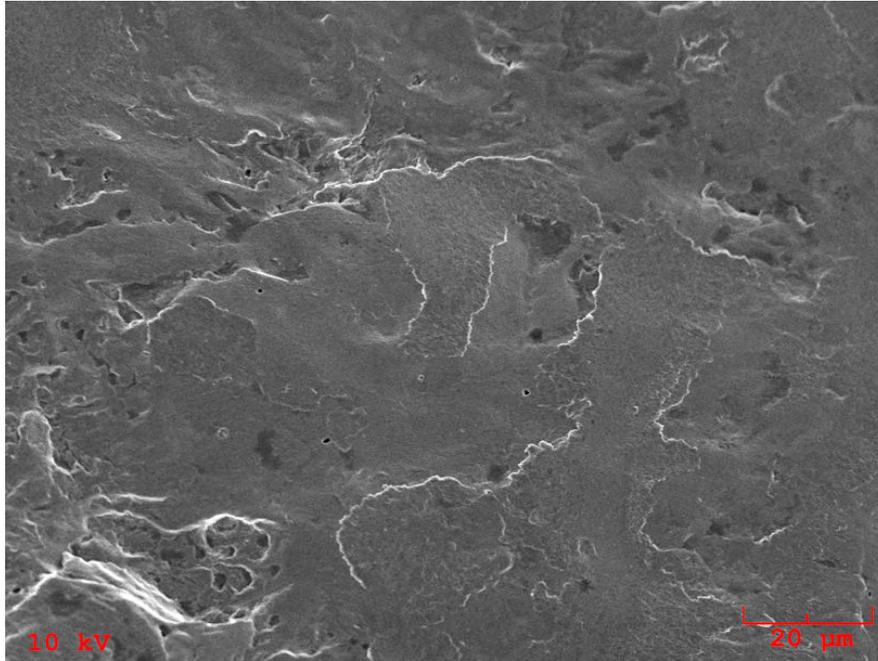
Figure 11: Secondary electron image of a jack shaft fracture near the origin. Fractographic features have been obliterated by post-fracture rubbing.

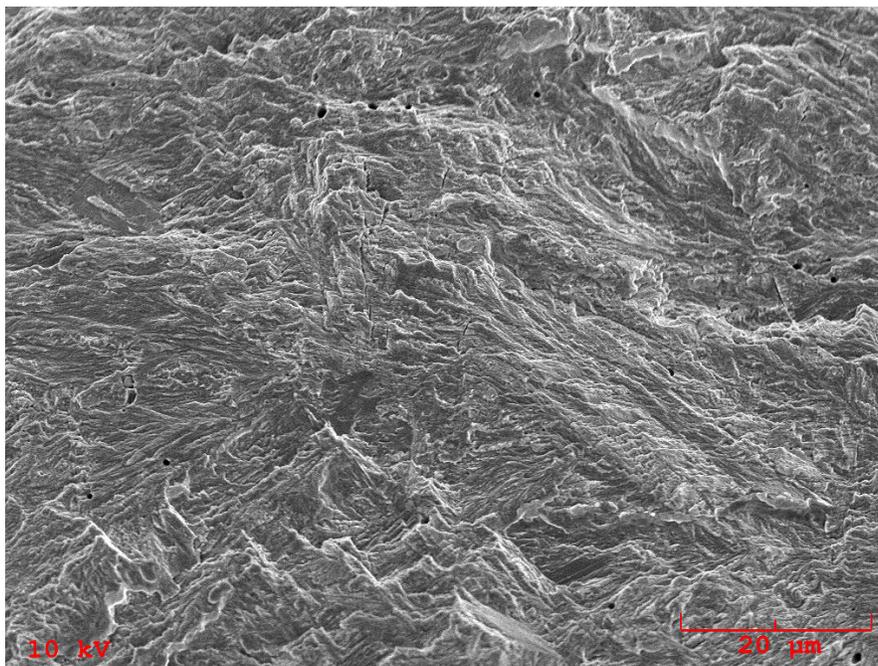
Figure 12: Secondary electron image of a jack shaft fracture from the region of visible beach marks, showing fractographic features consistent with fatigue.

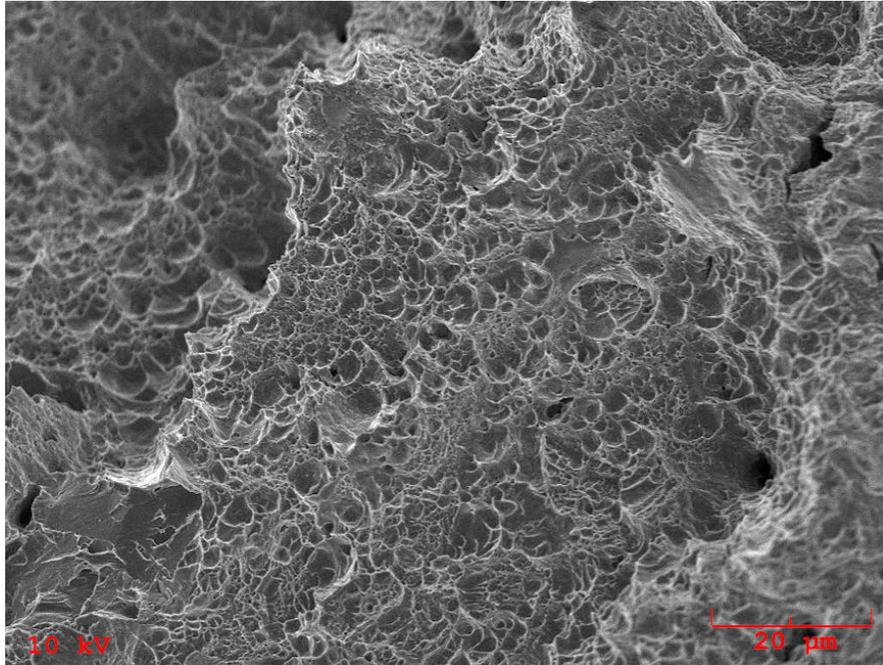
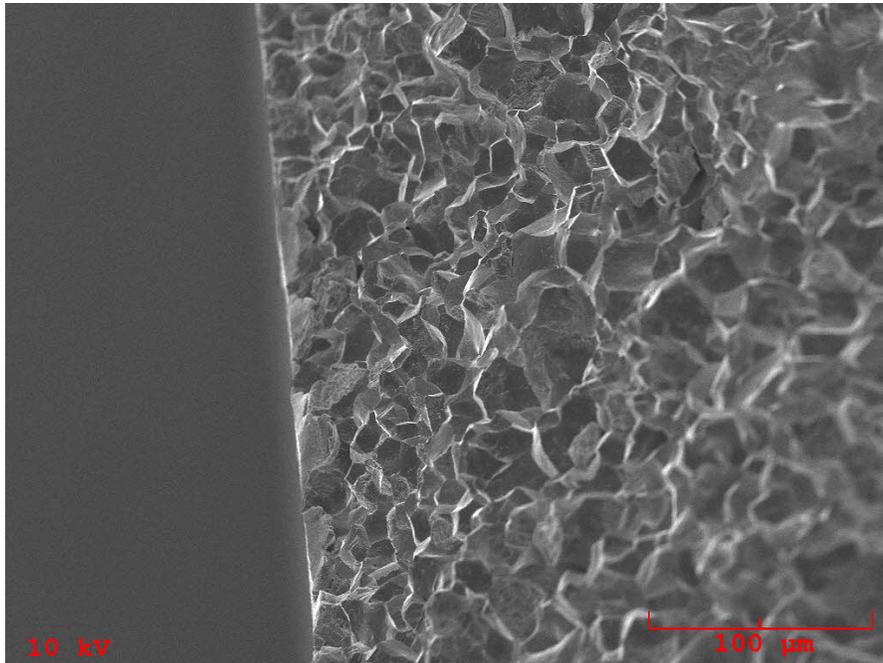
Figure 13: Final overload regions of the jack shaft fractures were comprised of dimpled rupture in the core (top image), with intergranular separation through the case-hardened area.

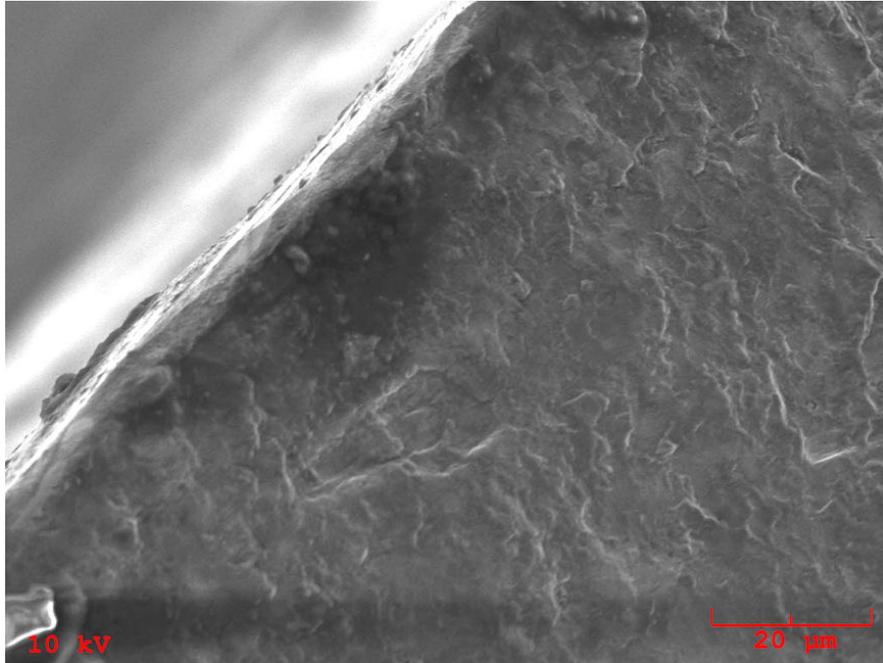
Figure 14: Secondary electron image of the 98765 shaft fracture near the origin. Fractographic features have been obliterated by post-fracture rubbing.

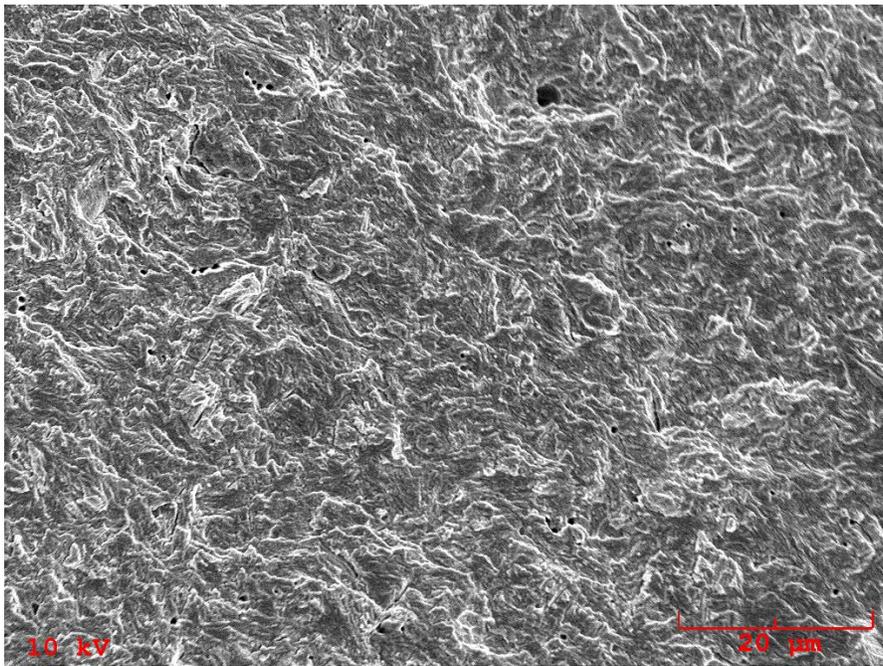
Figure 15: Secondary electron image of the 98765 shaft fracture in the region of visible beach marks, showing evidence of fatigue.

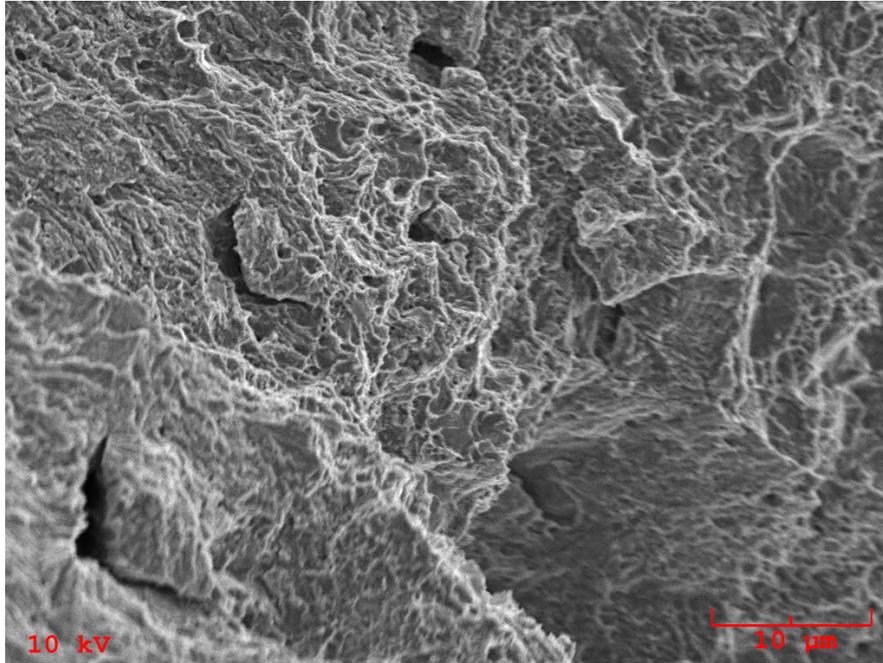
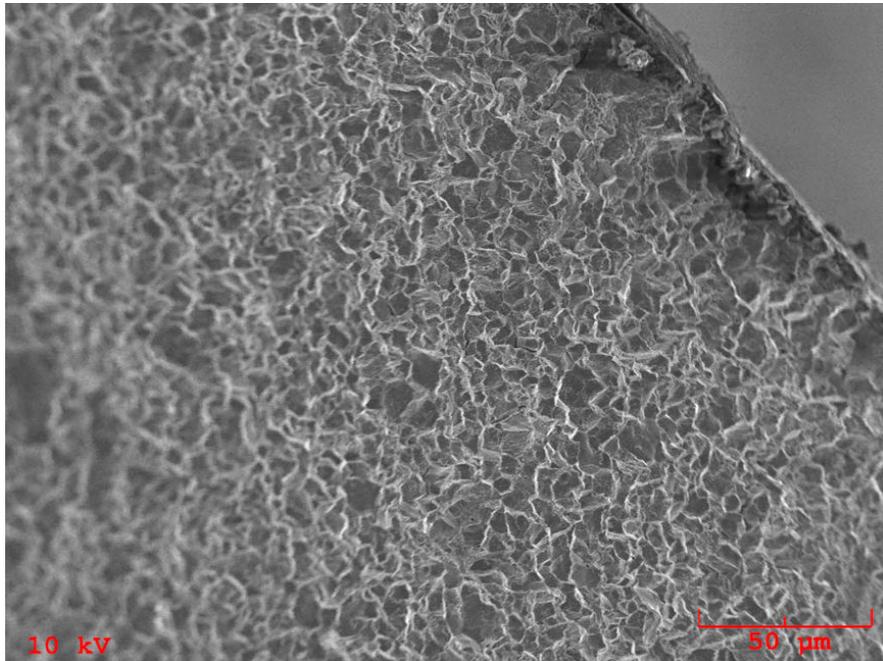
Figure 16: Final overload regions of the 98765 shaft also consisted of dimpled rupture in the core (top image), with intergranular separation through the case-hardened area.

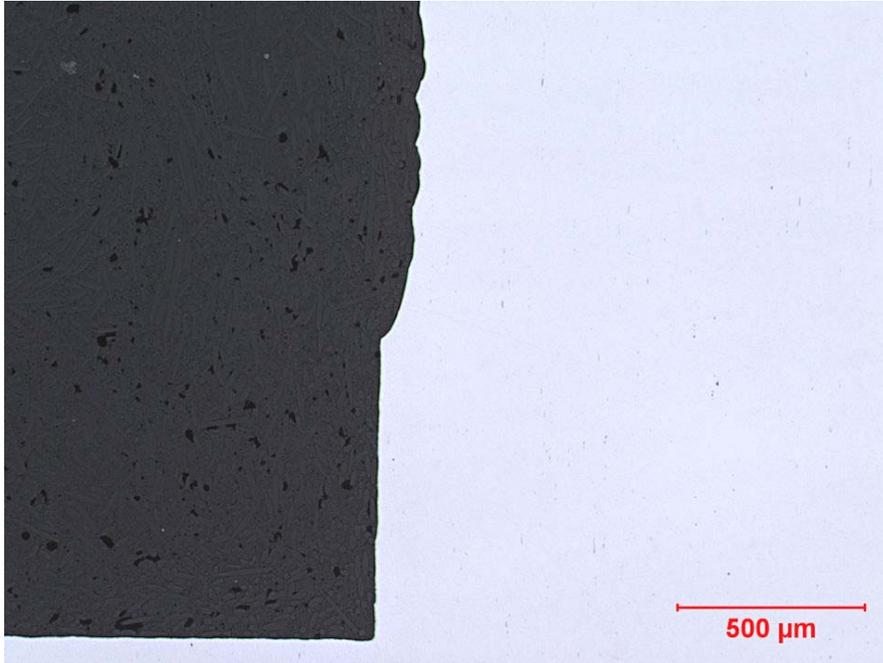
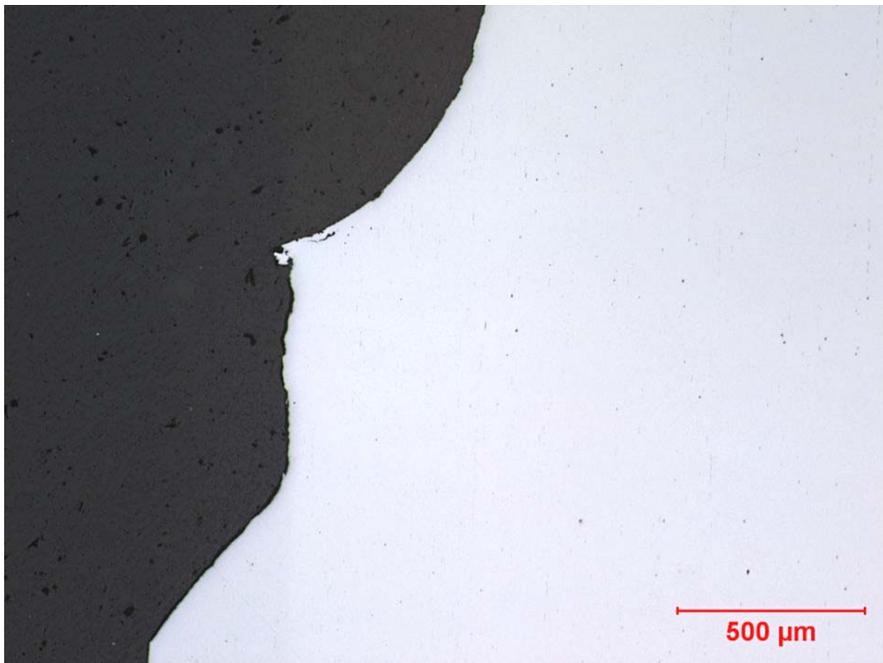
Examination in the as-polished condition reveals the extent of material loss at the engagement points of the jack shafts and 98765 gear shaft. Wear depth was much greater on the 98765 gear shaft than either of the two jack shafts. See Figure 17. Secondary cracking, beneath the primary fracture, was observed on the jack shaft with fractures on both sides of the male tang (Figure 18). No secondary cracks were observed on the 98765 gear shaft or cracked jack shaft. Intergranular oxidation was noted at the surface of each sample, ranging in depth from 2 to 10 µm (Figures 19 – 21). Intergranular oxidation is known to adversely affect fatigue resistance.

Figure 17: Images showing the material loss in the worn regions of the jack shaft (top image) and 98765 gear shaft. Material loss on the gear shaft was much more pronounced.

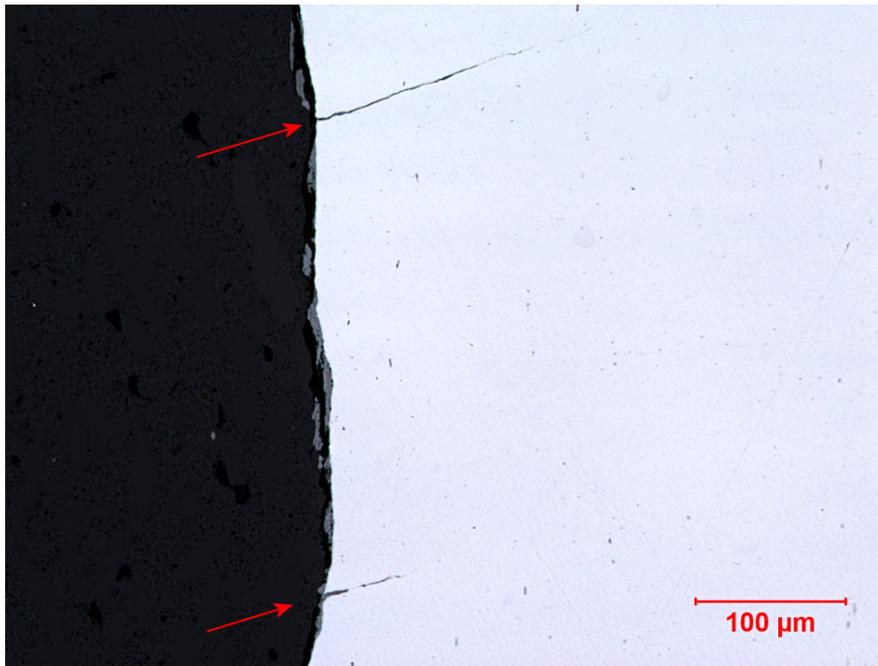
Figure 18: Secondary cracks were observed in the worn area below the main fracture on the jack shaft with fractures at both engagement regions.

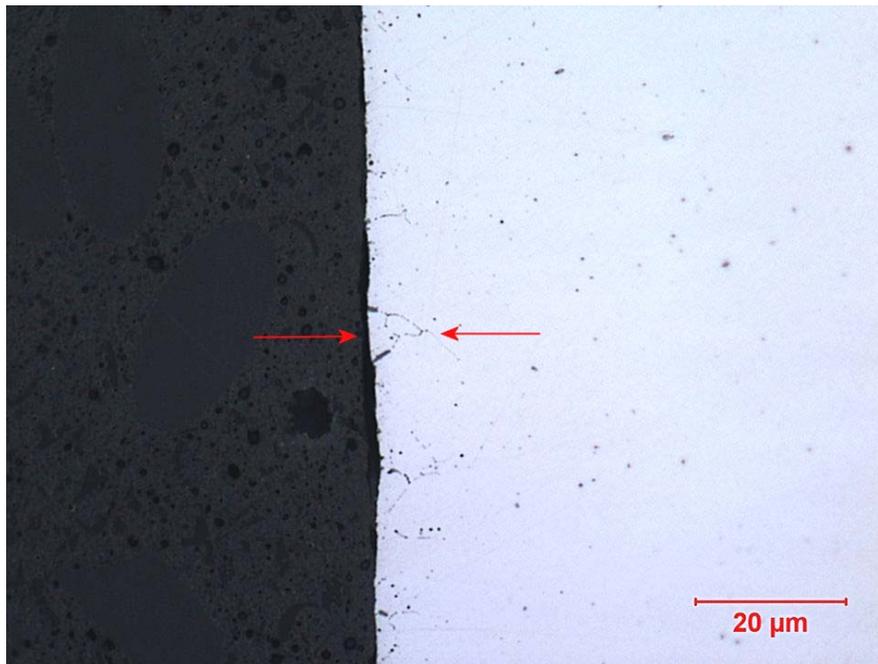
Figure 19: Intergranular oxidation (between arrows) observed in the jack shaft with the incomplete fracture.

Minimizing the amount of retained austenite (lowering carburizing temperature, cryogenic treatment prior to tempering, modification of quench rate) and intergranular oxidation (maintaining proper carburizing atmosphere and dew point) will help to curtail the observed fractures.

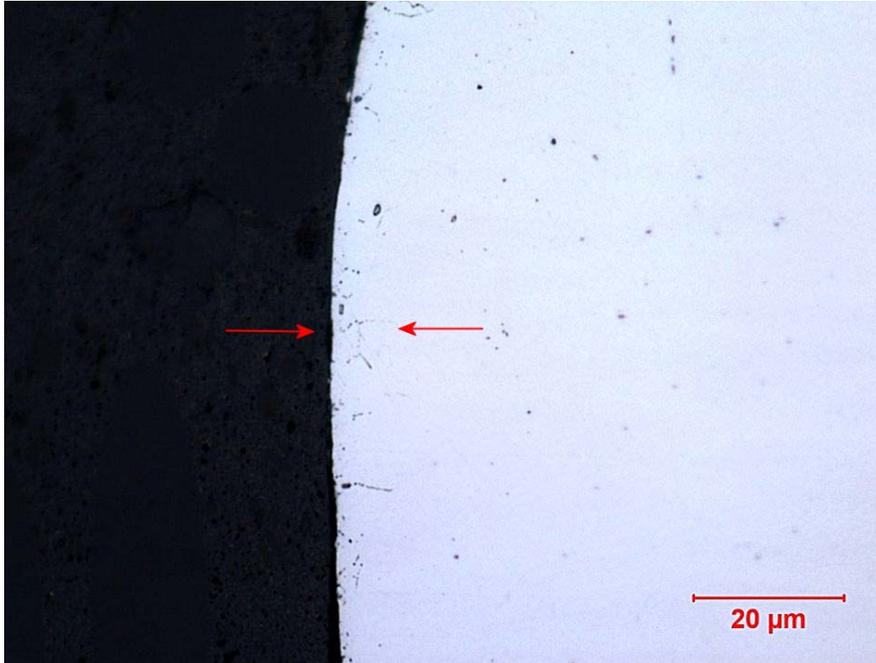
Figure 20: Intergranular oxidation (between arrows) observed in the jack shaft with fractures at both contact points.

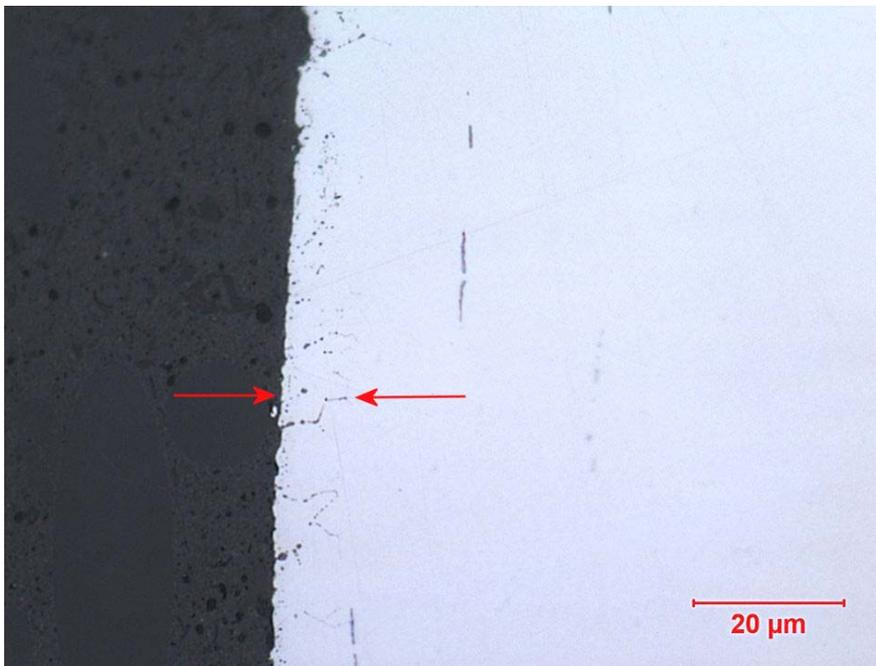
Figure 21: Intergranular oxidation (between arrows) observed in the 98765 gear shaft.

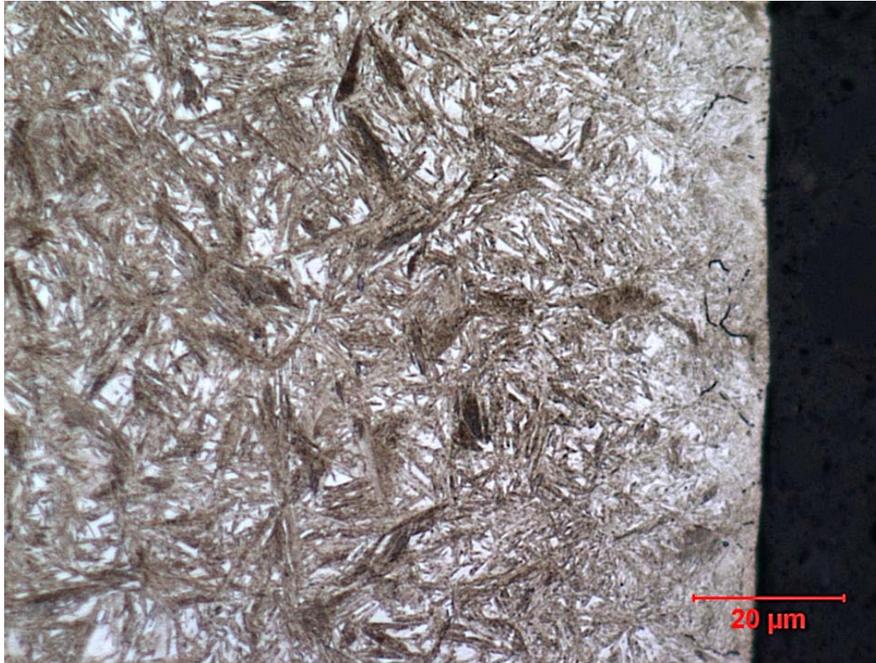
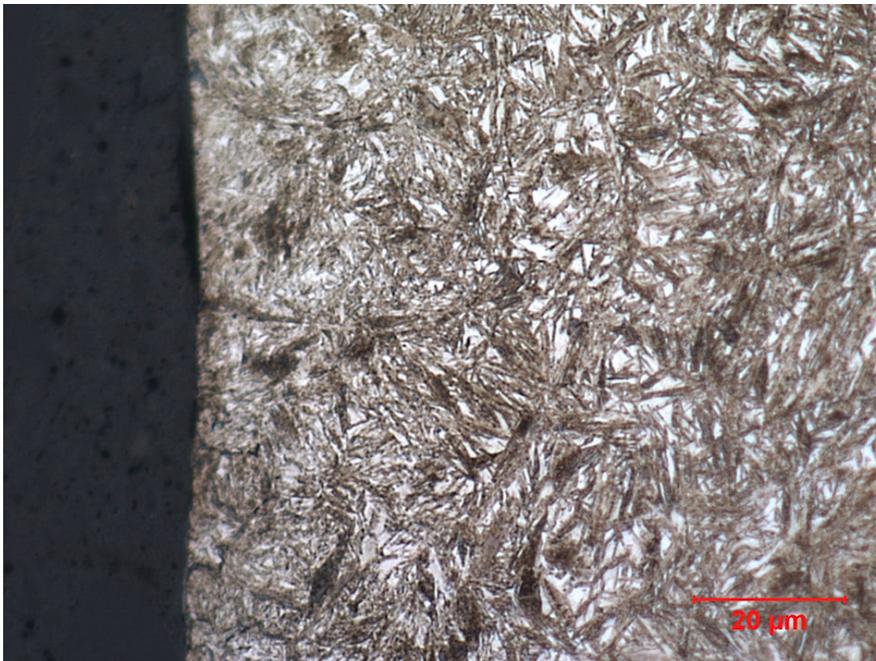
The microstructure of each component was similar, consisting of martensite and retained austenite in the case hardened region, with martensite and some ferrite in the core (Figures 22 – 24). Retained austenite percentage was estimated visually based on photographs within the Metals Handbook, Atlas of Microstructures, 8th Edition, Volume 7. Percent retained austenite for both jack shafts is estimated to be 30 – 35%, while the 98765 gear shaft contained 20 – 25%*. Significant amounts of retained austenite are considered detrimental, as austenite is soft – causing accelerated wear, and can be transformed to un-tempered martensite (which is brittle and can contribute to crack initiation) under load.

Figure 22: The case microstructure of both jack shafts (top image – jack shaft fractured at both engagement points) showed significant amounts of retained austenite (white constituent).

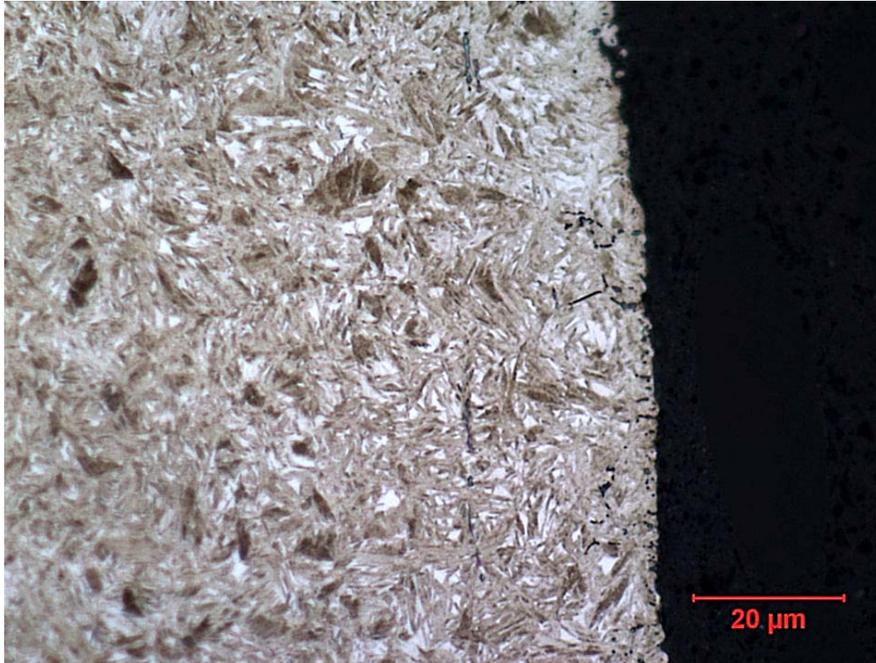
Figure 23: The 98765 gear shaft case also contained retained austenite.

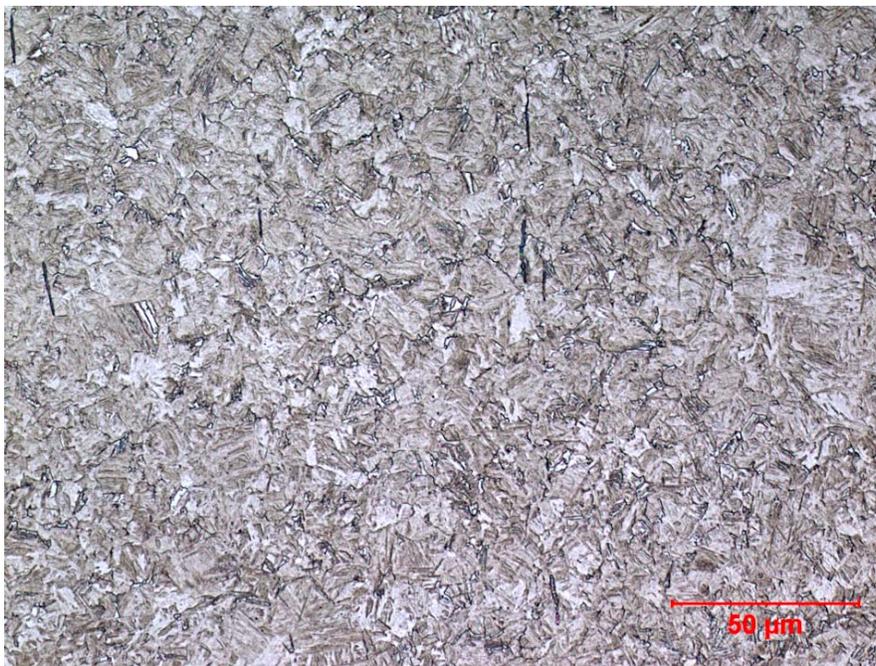
Figure 24: The core microstructure of all three fractured components was similar, consisting of martensite and small amounts of grain boundary ferrite.

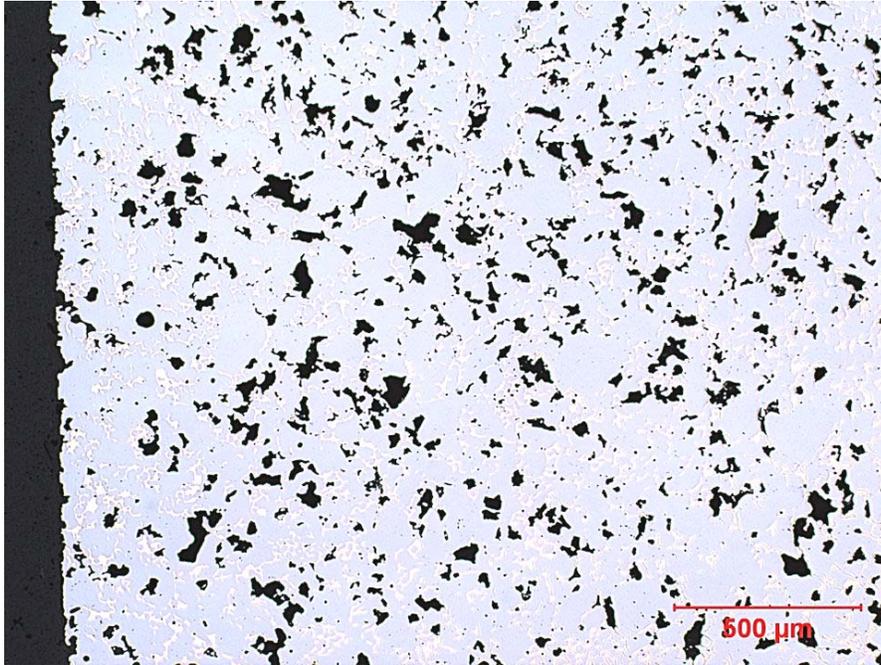
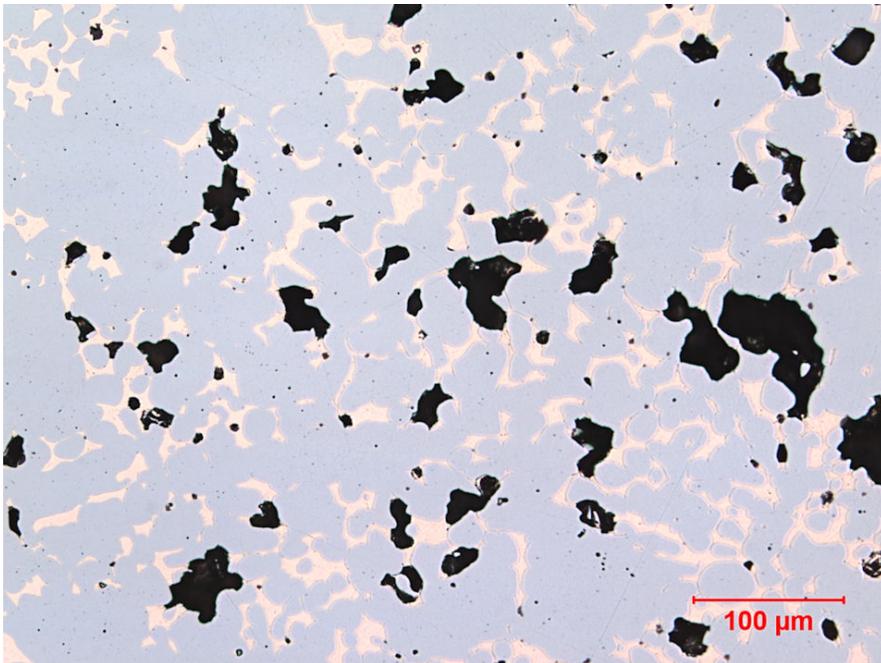
Examination of the jack shaft provided for comparison reveals a pressed and sintered powder metal material, with pores present at prior particle boundaries. Porosity was uniformly distributed throughout the sample cross section, and was measured at 13% via image analysis. Free copper was present throughout the microstructure, located primarily at prior particle boundaries. See Figure 25. No evidence of intergranular oxidation was observed.

Figure 25: As polished view of the jack shaft utilized for comparison, showing typical porosity distribution and morphology. Note the presence of copper.

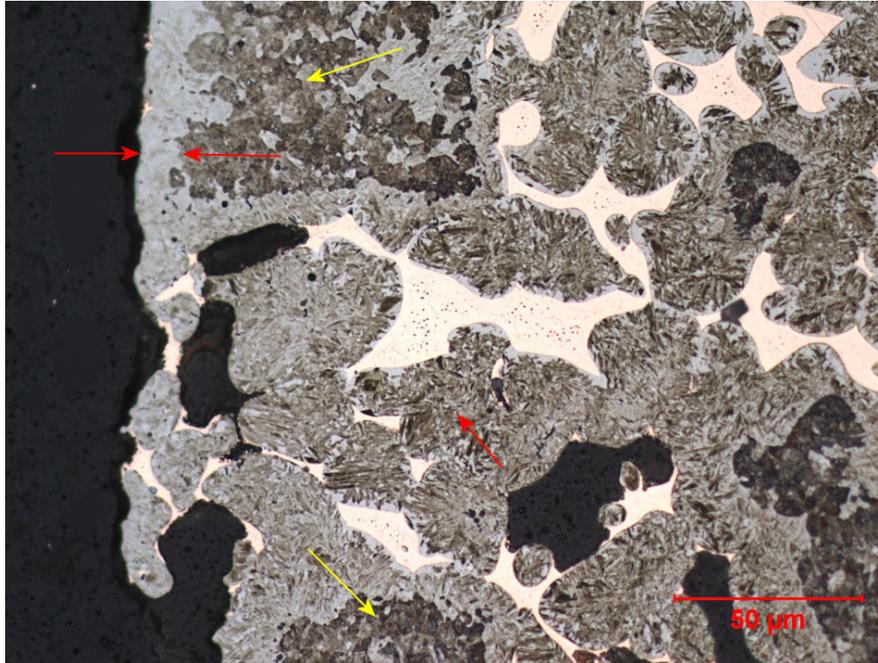
Etching of the comparison jack shaft reveals a mixed microstructure consisting of martensite, bainite and fine pearlite throughout the cross section (Figures 26 and 27). The mixed microstructure indicates heat removal from the austenitizing temperature was not rapid enough to cause complete transformation to martensite. No retained austenite was observed.

Figure 26: Microstructure of the comparison jack shaft in the contact regions was comprised of fully hardened martensitic regions (red arrows) and areas of upper transformation products (yellow arrows).

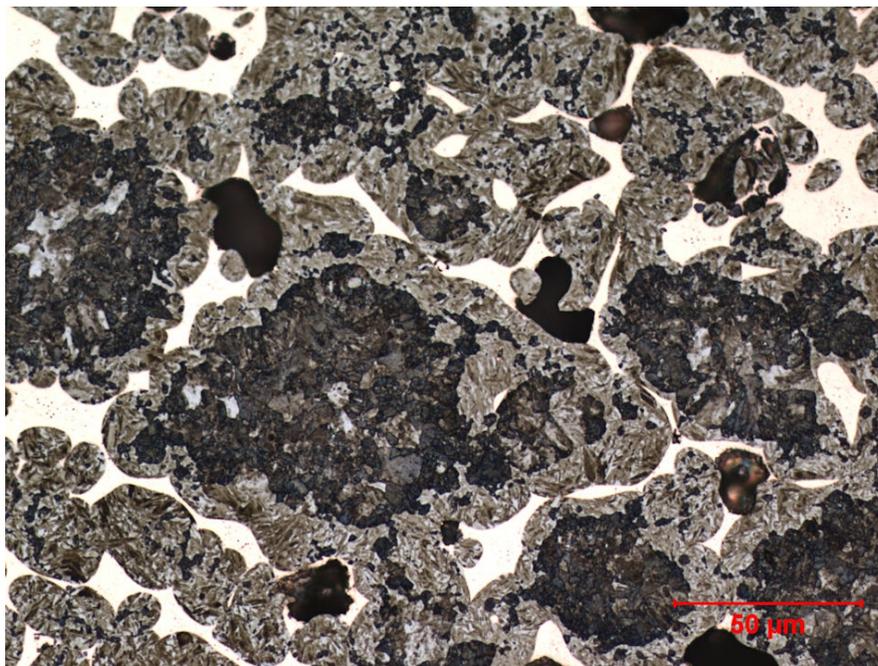
Figure 27: Core microstructure of the comparison jack shaft also consists of a mixture of martensite, bainite and fine pearlite.
