ANALYSIS OF PUMP SHAFT COUPLINGS

IMR Report Number 201000000

SUMMARY

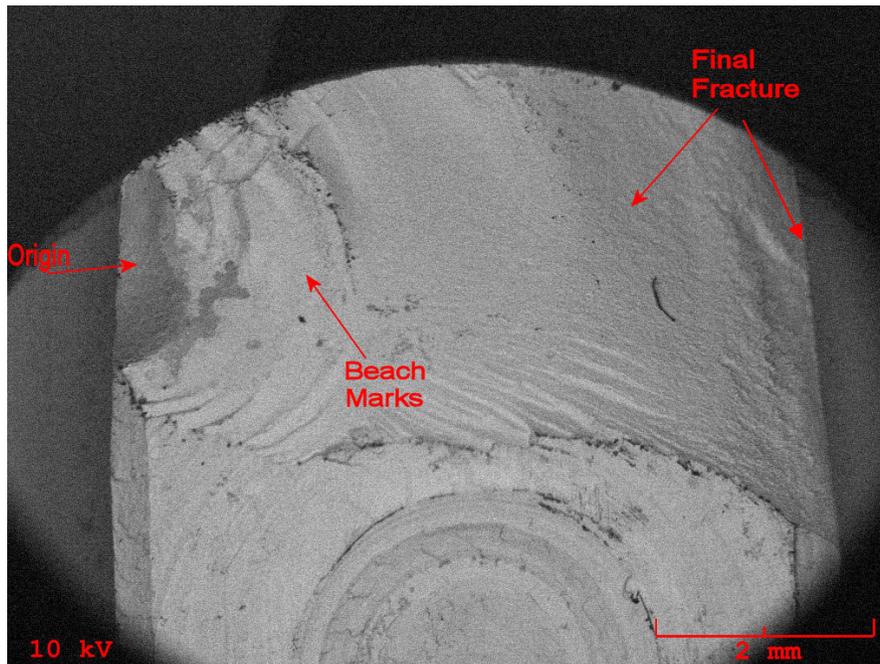
The fracture features observed on both jack shafts, as well as the 98765 gear shaft, were similar. Each component contains a region at the fracture origin with no distinct fractographic features, rubbed smooth by post fracture damage. Examination of regions with macroscopically visible beach marks reveals crack propagation occurred via cyclic loading (fatigue). Final overload regions for each component are comprised of dimpled rupture in the more ductile core, with intergranular separation in the case hardened regions. Figure 10 shows a macroscopic view of the fracture surface, with annotations providing approximate locations of the higher magnification images shown in Figures 11 – 16.

Figure 10: Low magnification backscatter electron image view of a typical fracture surface, showing the general locations of higher magnification images.
